I.M.L. Ridge¹, J.M. Teissier² and R. Verreet³

The effect of wire rope “safety” clamps on rope terminations

Summary

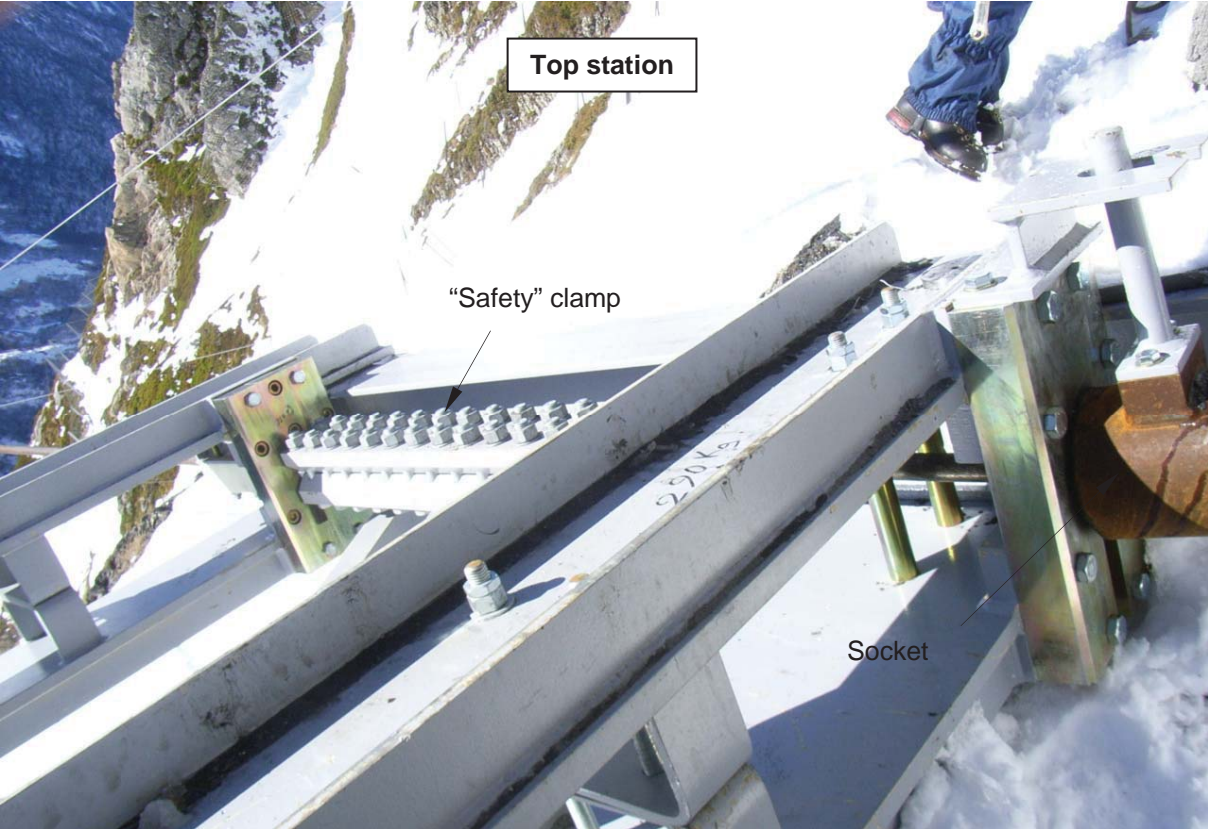
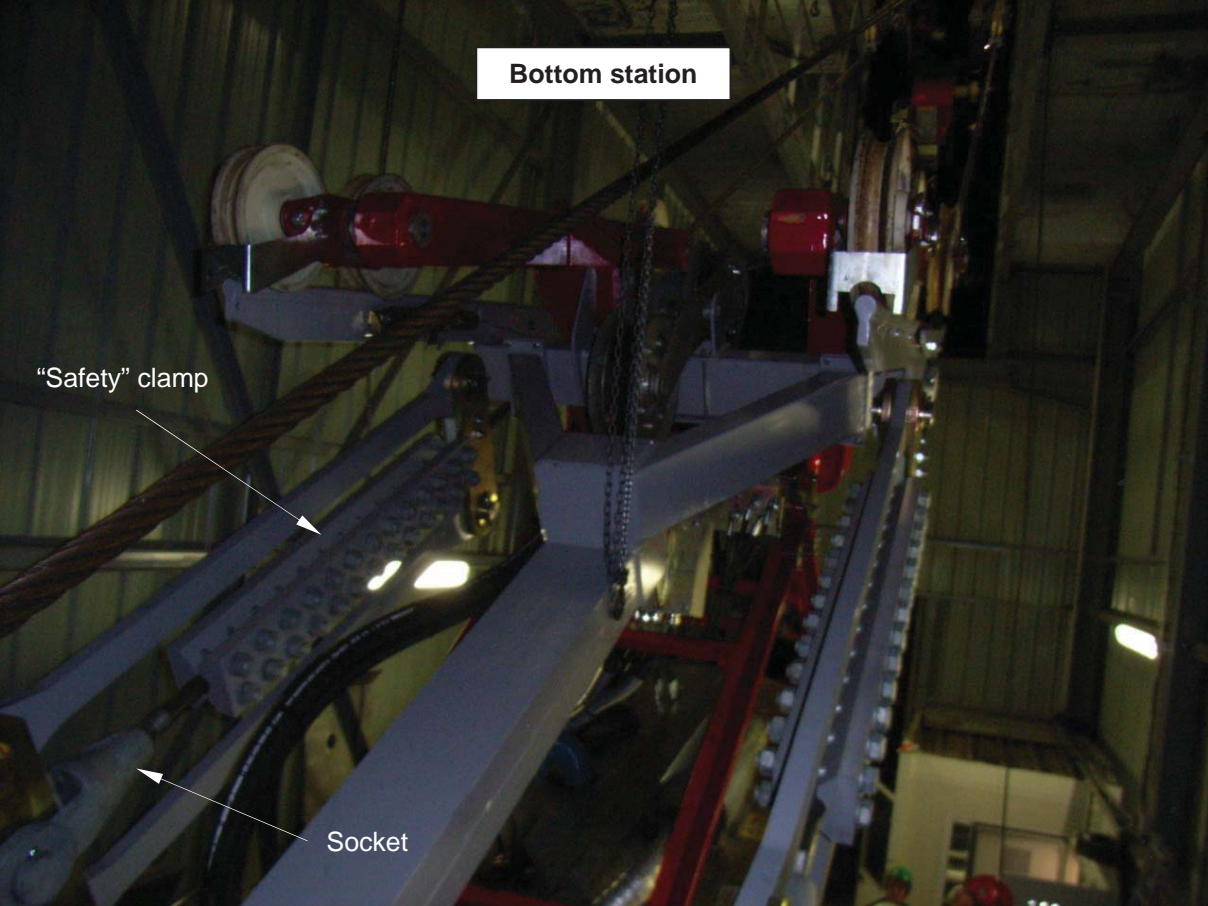
Figure 1: Showing safety clamps in service on an aerial ropeway.

Figure 1, below, shows an example of such a clamp in service on an aerial ropeway, and Figure 2 one in service on a bridge. The basic idea behind the use of the clamp is that should the filled socket fail, the clamp will provide sufficient holding force to maintain the integrity of the end connection. This is a completely different arrangement to other uses of rope clamps, for example on a winch drum where the clamp is an integral part of the assembly rather than an additional element.

Figures 1 and 2 show, that in order for the safety clamp to be effective, it has to be mounted on the rope in front of the socket, and is therefore on a section of rope which will experience the same service loading as the socket. Figure 3, (which is for another aerial ropeway) shows how the clamp is positioned within a supporting framework such that it will only support axial load should the main socket fail. The question arises as to whether the additional safety clamp really does improve safety, or whether its clamping pressure combined with the service loads will lead to accelerated wear and fatigue damage.

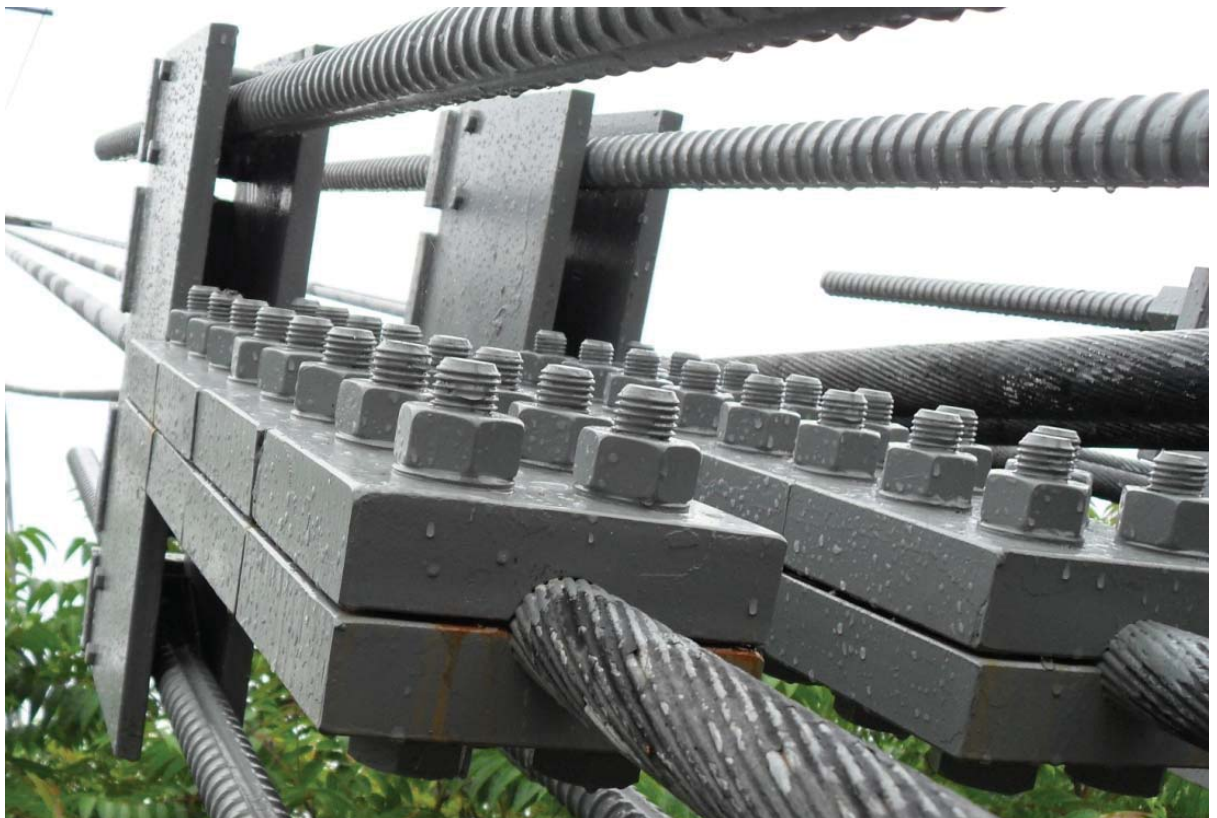
Figure 2: An example of a safety clamp employed on a cable stayed bridge.

The clamp which was designed and used in the tests reported here was a 'single' piece in that the clamping length was made of one continuous section. Reference to Figure 2 shows that for ease of installation, clamps may be made up of several shorter sections. The work undertaken here has not addressed how the fretting amplitude may be affected by this difference in design, but it might be expected that shorter clamps would lead to reduced fretting motion, but in more places (at the entrance and exit to each clamp section).

Figure 2 also shows evidence of some local corrosion associated with the rope clamp. It is not clear what the source of the rust is – but it is likely that the clamp acts in some way to allow water to sit on the rope/clamp assembly, which is clearly undesirable.

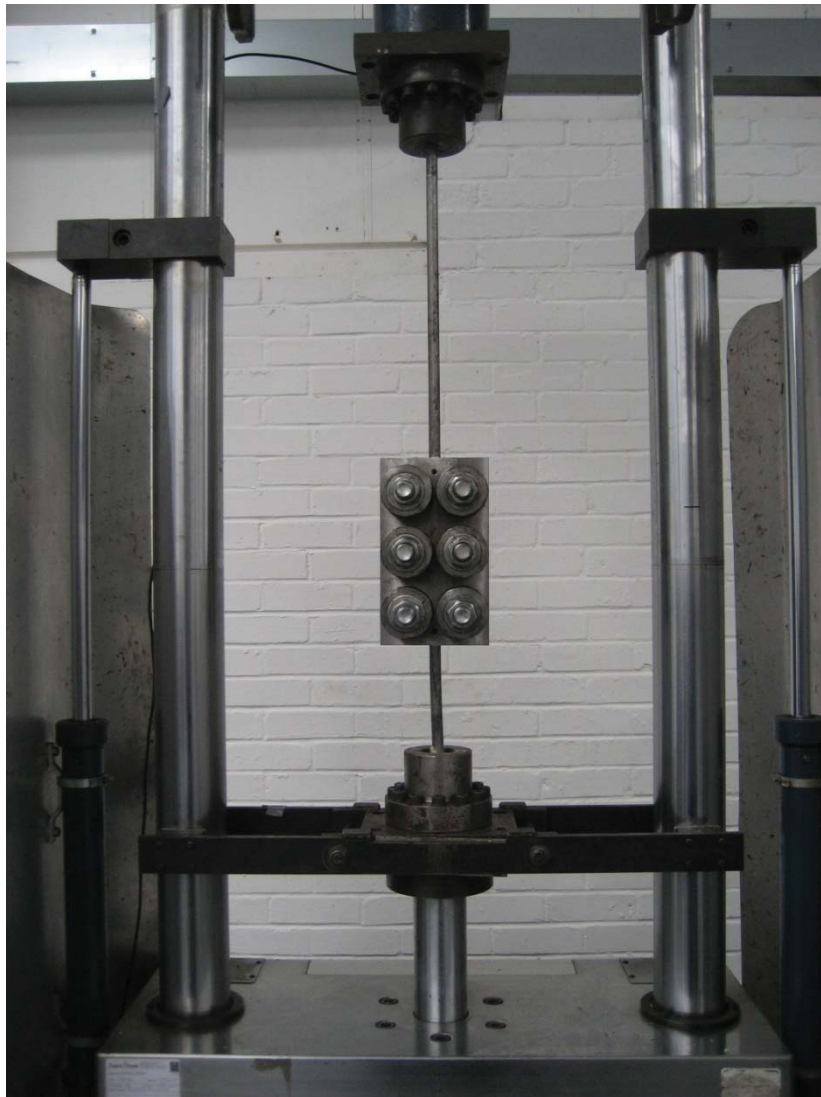
Figure 6: General view of rope safety clamp installed on a FLC rope tensile fatigue sample.

Where required, the clamp was installed on the rope about 150 mm above the lower termination (Figure 6). The rope was put under a nominal tension before the clamp was fitted. The Belleville washers were well greased and placed in the specified stacking configuration.

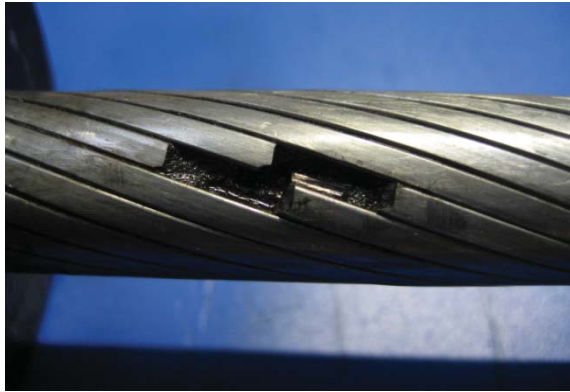
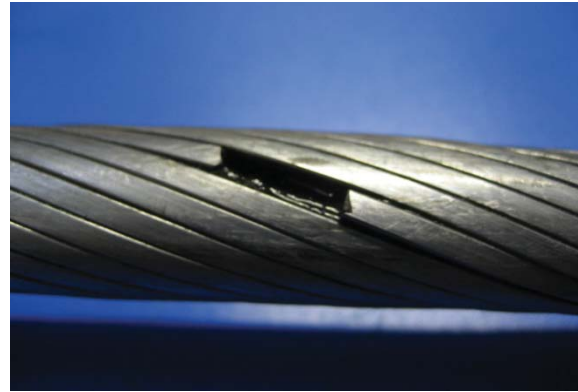
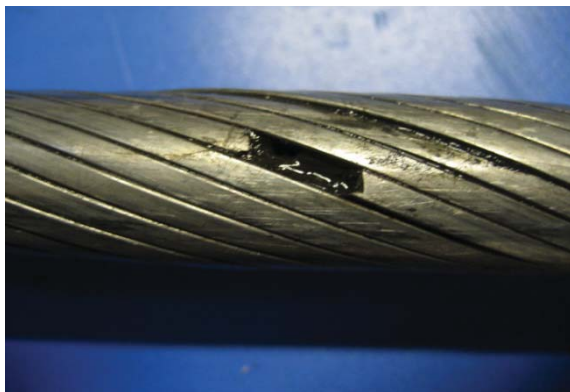
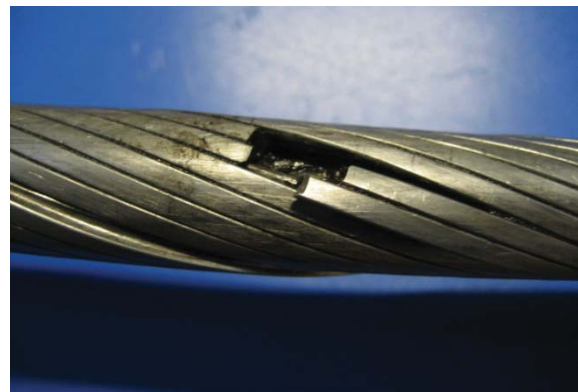
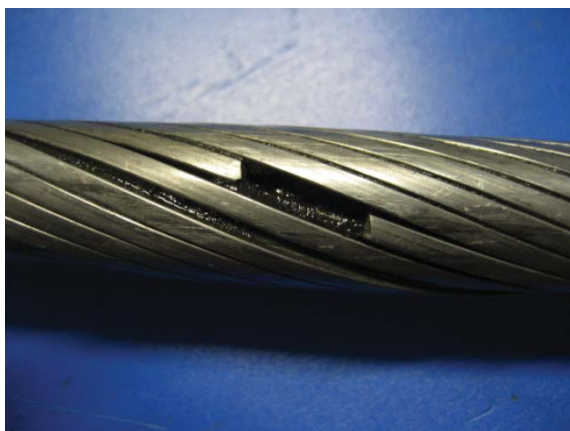
(a) Two wire breaks at 25 mm

(b) Single wire break at 99 mm

(c) Single wire break at 230 mm

(d) Two wire breaks at 360 mm

(e) Single wire break at 435 mm

(f) Two wire breaks at 515 mm

Figure 8: Close up view of Z wire breaks on the tensile fatigue sample (Test FLC04) after failure at 501,227 cycles and following cleaning in degreaser. Air gaps were approx. 10 mm.

The FLC04 result was considered very satisfactory. A single Z wire break was noted 230 mm above the lower termination at 321,842 cycles, and there were wire breaks along the length of the FLC sample and all clear of the terminations on completion of the test. Table 4 lists the wire breaks which were noted in the outer Z wires upon cleaning and inspection of the failed sample. It is noted that the distortion of the sample suggests that the inner layers were broken in many places, but these have not been individually recorded. Figures 7 and 8 shows appearance of the sample and close up views of the groups of wire breaks.

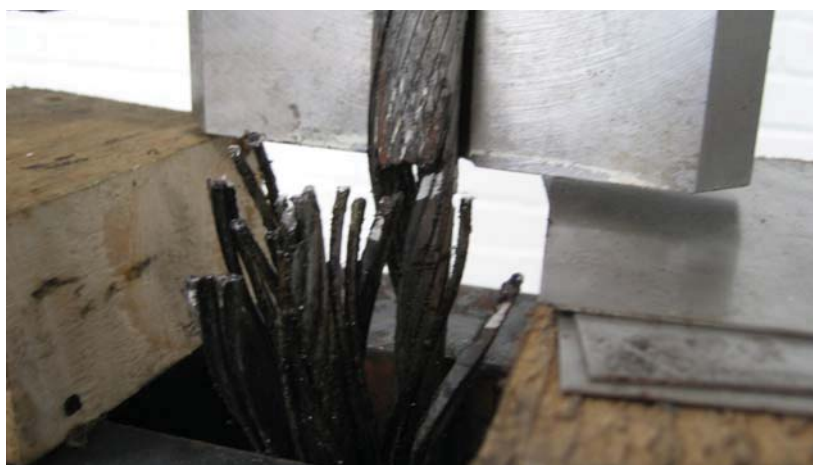
Figure 10: Clamp lower exit point at which the main failure occurred. Note the Z wires which were at the 'sides' of the clamp groove have not failed. Note also the fretting rouge at the position of the rope just inside the clamp.

Figure 9 shows the test FLC02 with the rope clamp which failed after 102,305 cycles. Figure 10 shows the rope failure location at the bottom of the clamp with the front half removed. It can be seen that several of the Z wires (ten were counted on later inspection) and all of the inner round wires have failed. Figure 11 shows the corresponding condition of the rope at the top of the clamp. Two views are shown 'front' (as viewed in Figure 9) and 'back'. A total of seven failures in the Z layer wires can be seen. It is noted that none of these wire breaks could be seen with the clamp in position as the breaks were just 'inside' the clamp.

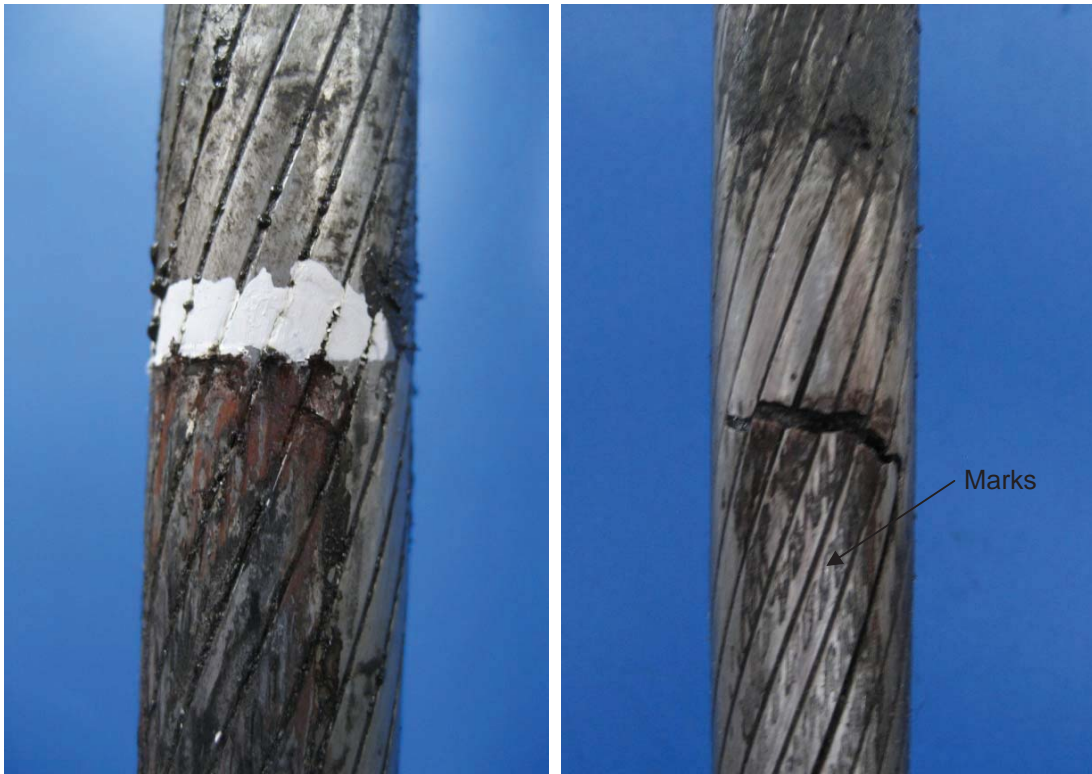
Figure 11: Clamp upper exit point ('front' (left) and 'back' (right)). Note the wire breaks and fretting rounge at the position of the rope just inside the clamp (the edge of the clamp is marked on the front view with the white paint). It is thought that the marks on the Z wires (back view) are from the damage to the clamp from the previous tests on the six-strand rope.

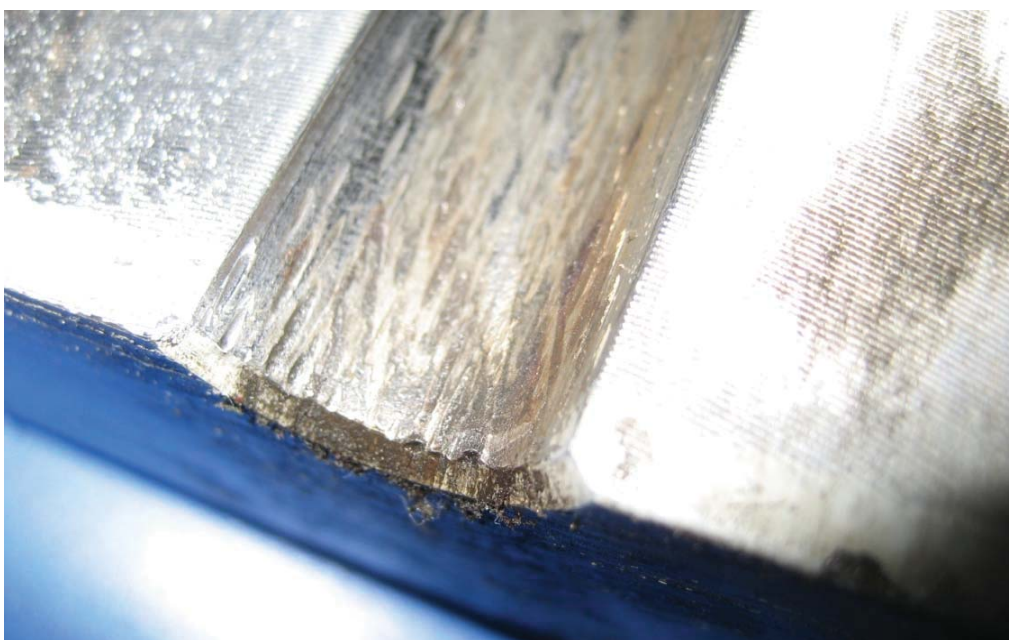
Figure 12: Typical condition of the clamp groove at the exit points after the fatigue test (FLC02).

The standard [2] also specifies that special care shall be taken to provide a radius at the exits of the clamps to avoid any sharp edges in these areas. For the test clamp a chamfer 1 mm x 45° was machined at each end of the clamp grooves (this can be seen in Figure 12).

Finally, Figure 12 shows the typical condition of the rope clamp groove in the area close to the ends. Note the damage to the chamfer caused by the broken Z wires which would have sprung slightly out of the rope construction. There is also some damage which was pre-existing from the earlier test on the six-strand rope.

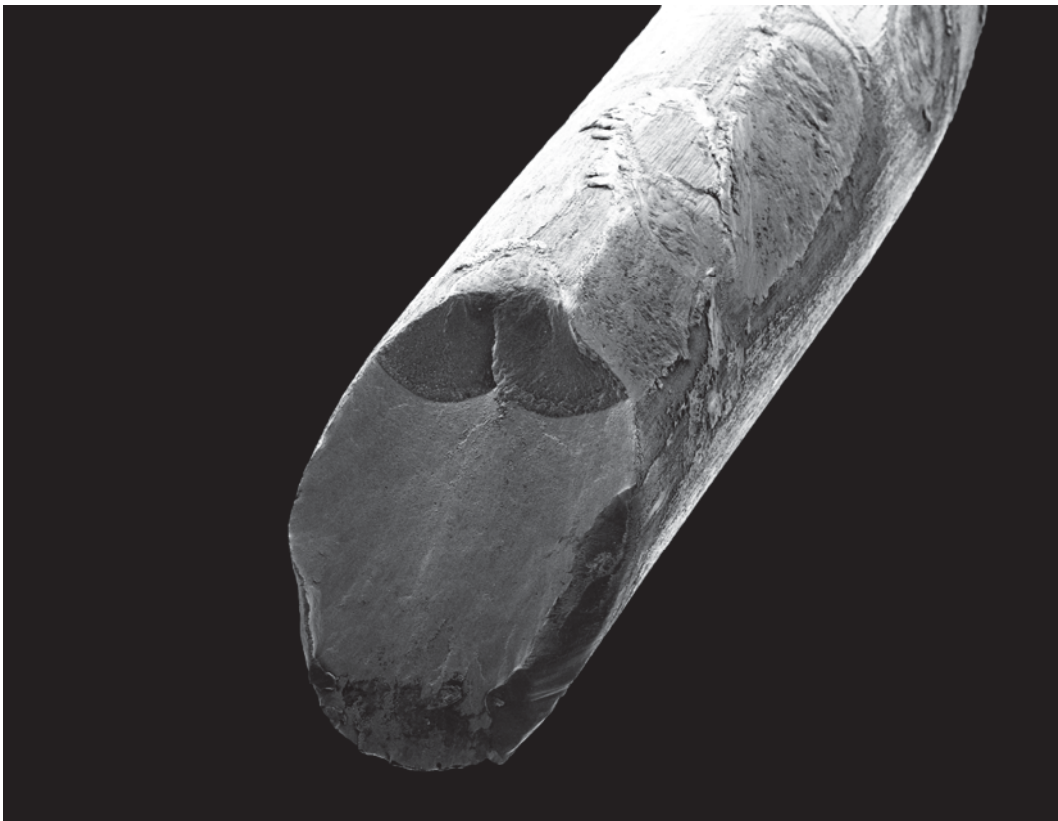
Figure 14: An internal round wire. Two adjacent fatigue cracks have started at points of contact with neighbouring wires. The wire finally failed in shear. (approximate magnification $\times 15$).

Figures 14 – 15 show views of fatigue breaks in the round internal wires. The wire in Figure 14 has two crack initiation points, one from each of neighbouring wires. Final failure has been in shear.
